Understanding **MP6500** Current Control

Application Note

Prepared by Pete Millett

April 2017

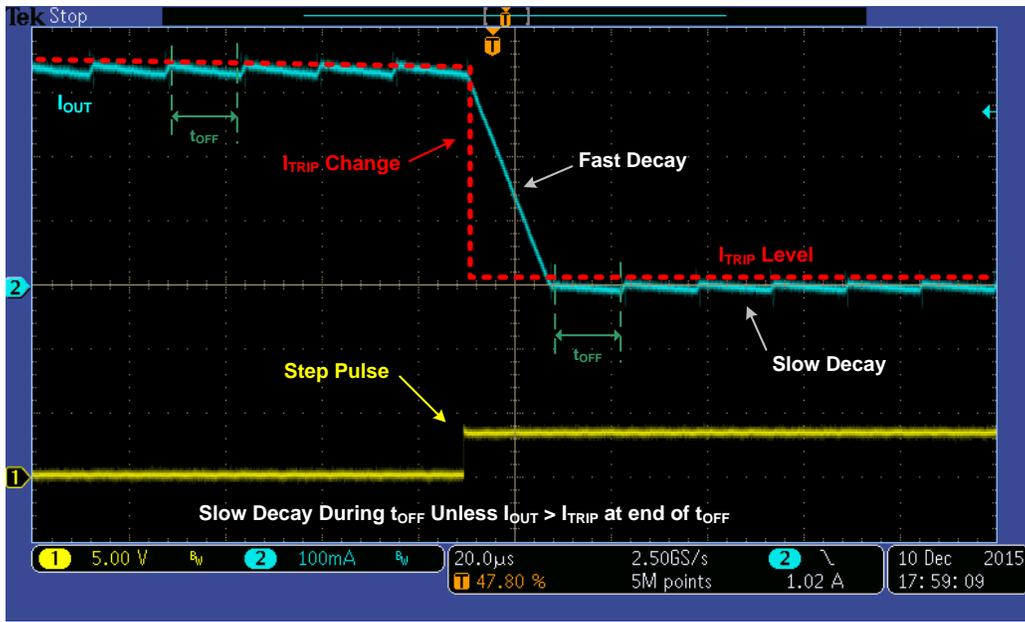
As a result of a step-pulse input, fast decay is needed frequently when the current must be driven toward zero. The waveform below in Figure 6 shows how the **MP6500** reacts to a step input that commands a decrease in current.

Figure 6: MP6500 Automatic Decay during Step Transition

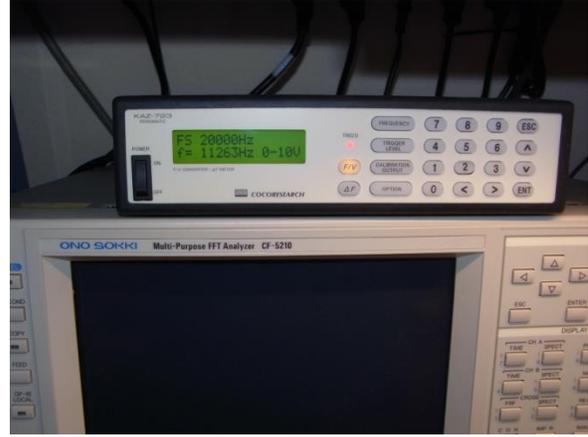
To make measurements of the motion, a frequency-to-voltage converter (Coco Research KAZ-723) was used to process the output of the optical encoder with its output observed on an oscilloscope and FFT analyzer. This output is a voltage that is representative of the motor speed updated at a very high rate.

Figure 10: KAZ-723 F/V Converter

This setup is shown in Figure 9 and Figure 10.

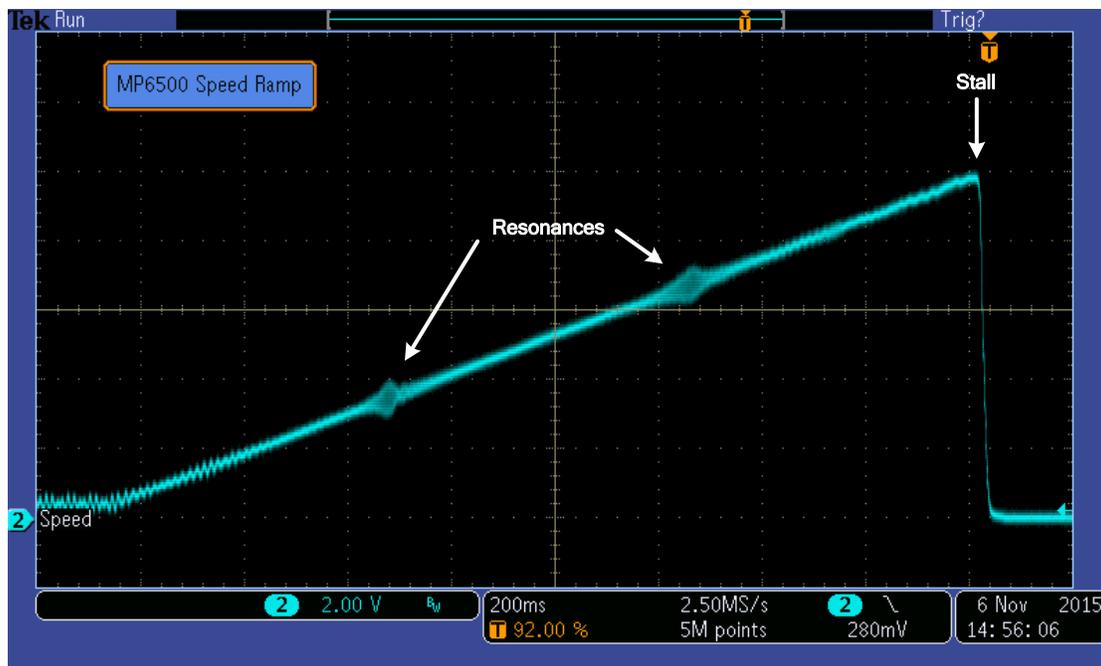
Using the same setup and winding current, the MP6500 shows the ability to drive to a significantly higher speed (see Figure 15). A stall occurs at a measurement voltage of about 10V, which corresponds to around 600RPM. This is due to improved current regulation at high step rates.

Figure 15: MP6500 Speed Ramp
